# A Review of Australian and New Zealand Investigations on Aeronautical Fatigue During the Period April 2009 to March 2011

**Air Vehicles Division**  
Defence Science and Technology Organisation

DSTO-TN-0993

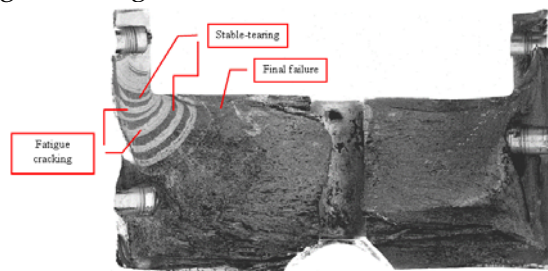
Figure 1: Fracture surface appearance of 7075 aluminium alloy lower wing spar from a Macchi MB326H, showing evidence of brighter regions of in-service fatigue crack growth, with progression markings interrupted by dull bands of stable tearing.

Fatigue fracture surfaces in a range of structural metals sometimes exhibit bands, visible as dull crescent-shaped regions which contrast to the “bright” background fatigue surface. Such bands as in Figure 1 are known as stable tearing and believed to be created within a single load cycle under either constant-amplitude (CA) or variable-amplitude (VA) load conditions. Essentially, stable tearing is a recurring process in which fatigue crack growth is interrupted by significant jumps of crack growth, usually at the central portion of the component while the crack-front lags behind near the free surface. Microscopically, crack advance by tearing has similarity to the final unstable fracture of the component, with the difference that the tearing is *stable*: it arrests after a certain distance of crack front advance, which is then followed by further fatigue crack growth.

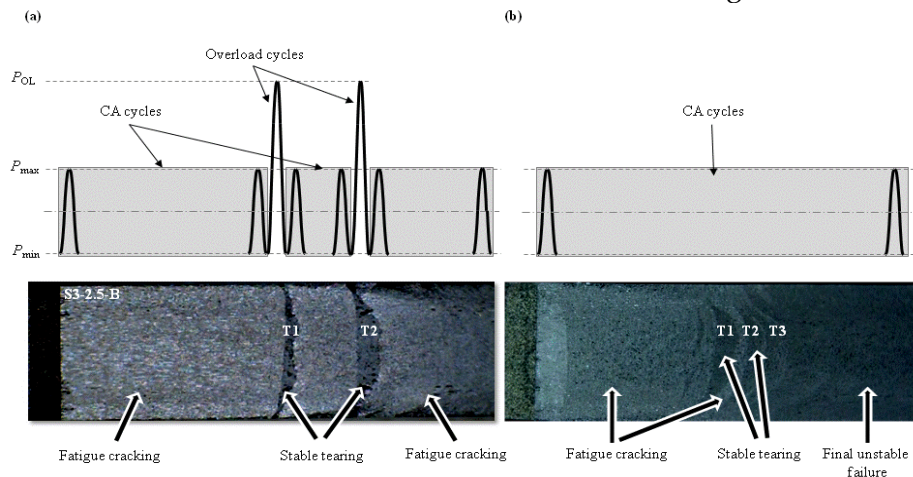
Figure 2: Stable tearing on fracture surface of a 6.5 mm thick 7075 aluminium alloy compact tension specimen. (a) The VA tear bands (marked T1 and T2) were produced during two high loads (overloads) in between background of low fatigue cycles; and (b) The three CA tear bands are marked as T1 to T3. The crack grows from left to right.

The other main conclusions relate to the notable differences between tearing under CA and VA loading. The CA and VA tearing are macroscopically different. The tearing after VA usually appears duller than the CA tearing, but both types of tearing are generally different to the fatigue crack growth region on fracture surface and both CA and VA tearing are also comparable to the face of the final unstable failure, as shown in Figure 2b.

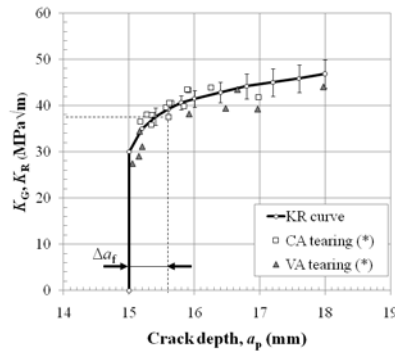
Figure 3: Distribution of tearing data against the static tearing curve.

The static tearing curve is developed based on the standard  $K_R$  curve test method. The  $K_R$  ( $K$ -value with plastic zone correction) is plotted against the physical crack depth  $a_p$  as shown in Figure 3. The fatigue tearing data from previous tests is found to agree very well with the static tearing curve, with the CA and VA tearing scatter in the upper and lower limit of the curve respectively, as shown in Figure 3. The  $K$ -value at which static tearing commences is

also approximately equivalent to the first onset stress intensity factor for VA tearing. This study suggests that the resistance curve method can be used to predict the first onset of tearing, and estimate the extent of tear under certain applied  $K$ .

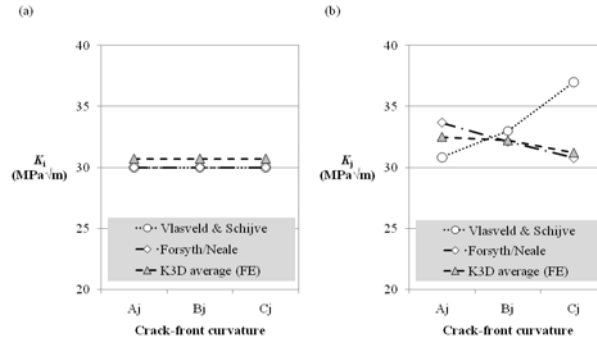
Figure 4: Comparison of  $K$ -values for three crack-front curvatures by using Forsyth and Schijve models, and computed through thickness  $K_{3D}$ . The  $K$  values at (a) onset of tearing; and (b) tearing arrest.

The complex crack front curvatures observed at tearing arrest distort simple estimates of stress intensity factor and three-dimensional (3D) finite element (FE) analysis has been undertaken to estimate the through thickness stress intensity factor  $K_{3D}$  variation. Generally, the  $K$ -value at mid-thickness region reduces, while the  $K$ -values at the sides of the specimen increase as the crack-front becomes more curved. Figure 4 shows that the computed  $K_i$  and  $K_j$  at initiation and arrest of tearing show good agreement with the  $K$ -values estimated from the empirical models for analysing tearing. In all crack-front curvature at tearing arrest, the computed  $K$  values lies in between the  $K$ -values from the two models.

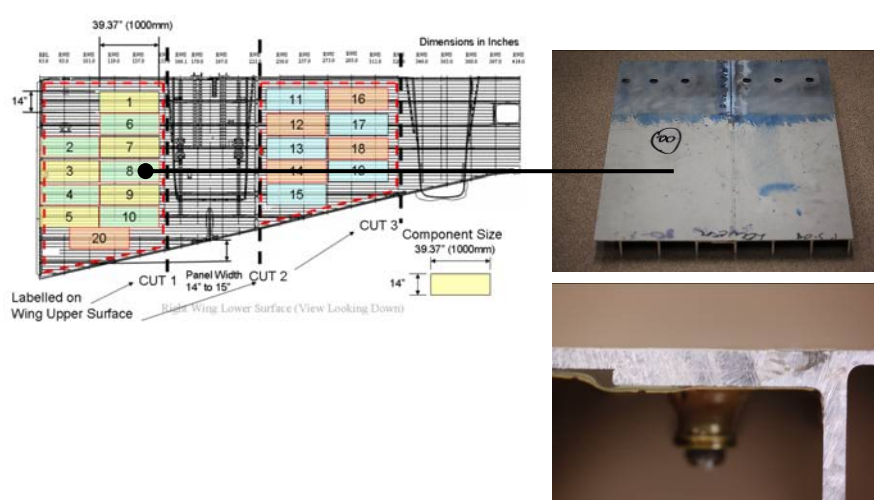
Figure 1: Schematic of P-3 lower wing panel cut-out

Scanning electron microscope (SEM) and energy dispersive x-ray spectroscopy (EDS) analyses were performed on a retired P-3 wing panel, allowing a close examination of the paint condition at the fastener area. The panel is made of 7075-T6 aluminium alloy and consists of internal and external splices fastened via a column of countersunk Eddie bolts, see Figure 1.

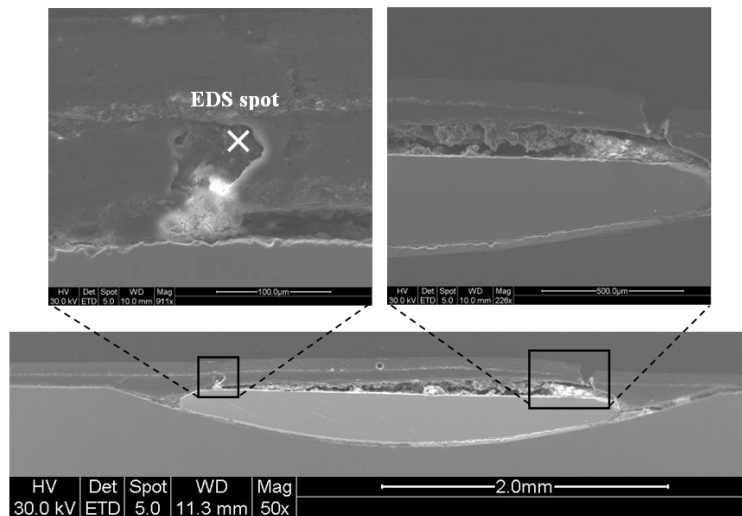
Figure 2: Scanning electron micrograph, showing paint defects and delamination underneath the paint film at fastener areas

SEM-EDS results revealed excellent paint surface finish away from fastener head regions; but exhibited substantial paint defects, in the form of cracking and dislocation of layers (delamination); all of which were observed around fastener areas, see Figure 2. Numerous short, blunt cracks approximately normal to the paint surface had developed both at the external surface and interfacial layer. The cracks appeared to be consistent with movement associated with the fastener tilting or the stress concentration associated with joints as substantial displacement is expected at these locations. The examination supported a correlation between paint failure/cracking and mechanical displacement.

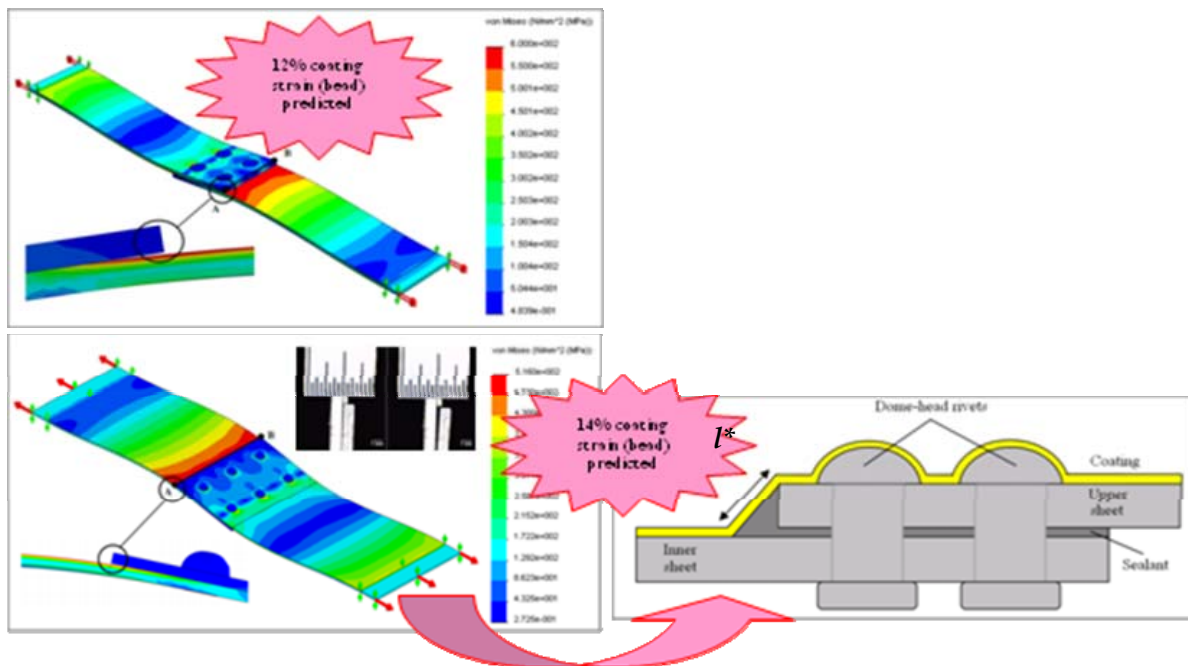
Figure 3: Finite element modelling, predicted strain along 45° sealant/coating bead

Finite element analysis was performed on two generic lap joints; one fastened with countersunk fastener, whilst another one with dome-head. For a 45° bead of sealant and coating, length  $l^*$  (see Figure 3), at the exposed sheet ends, the predicted coating strain was given as 12% (countersunk) and 14% (dome-head). This level of strain could reduce coating integrity, especially for aged coatings as the intrinsic material strength of coating decays over time.

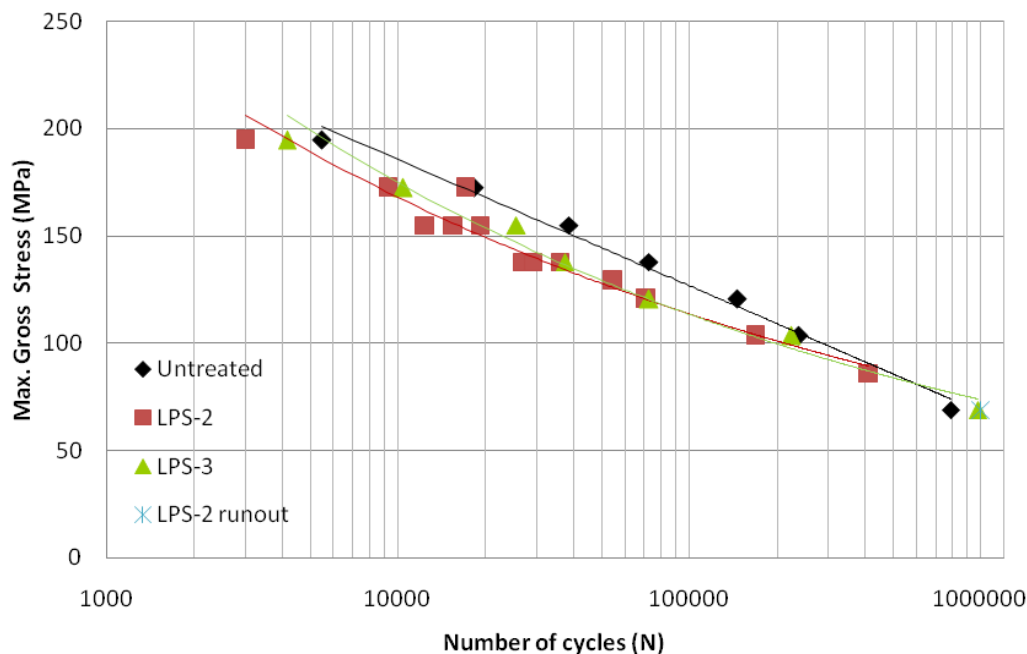
Figure 1: S-N plots of single lap joints with universal rivets and bare Aluminium sheets. The figure shows fatigue life comparison amongst untreated, LPS-2 treated, and LPS-3 treated specimens.

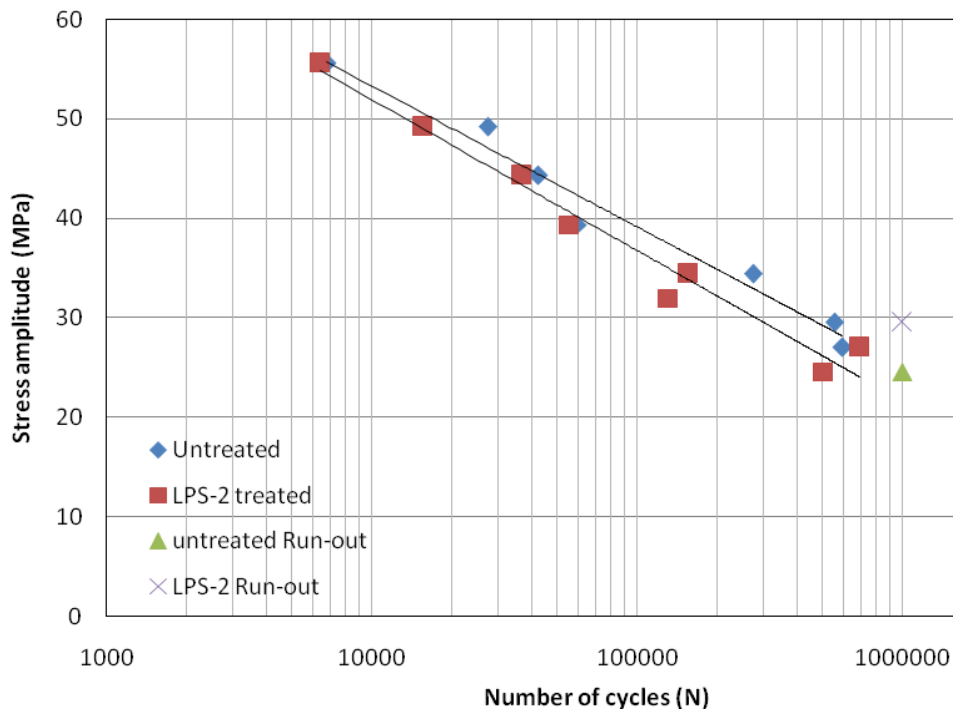
Figure 2: S-N plots of single lap joints with countersunk rivets and ALCLAD Aluminium sheets. The figure shows fatigue life comparison amongst untreated, LPS-2 treated, and LPS-3 treated specimens.

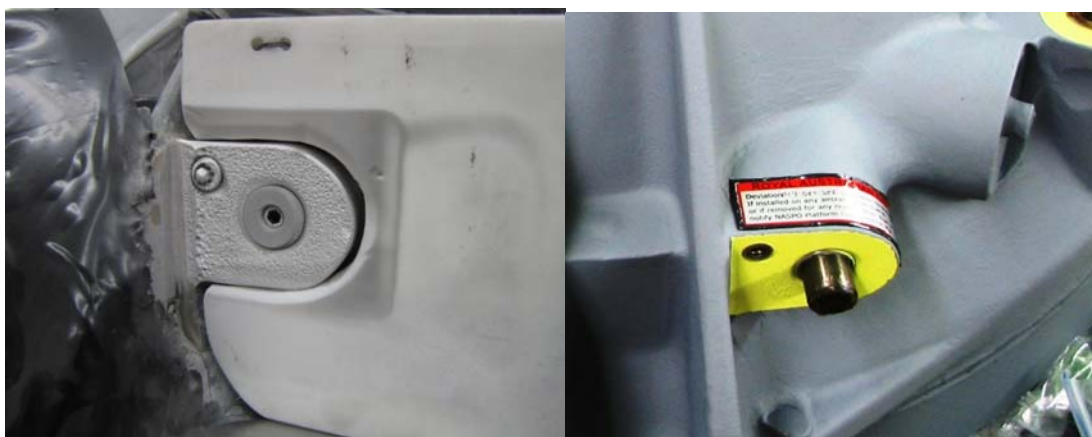
Figure 1: Rosebank Engineering Restoration of a Seahawk Helicopter Main Gear Box Module Aft Flight Control Pad, from [9].

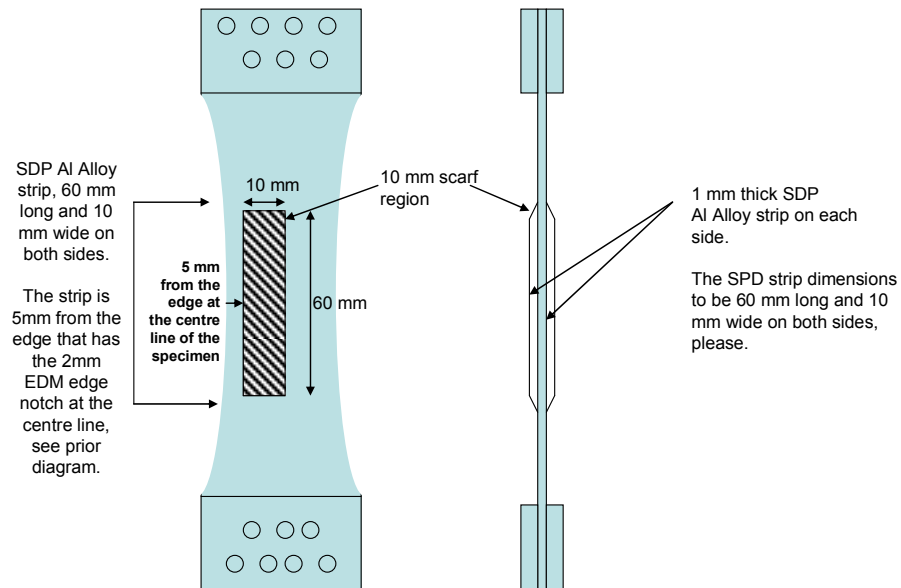
Figure 2: Schematic diagram showing the location of the SPD strip

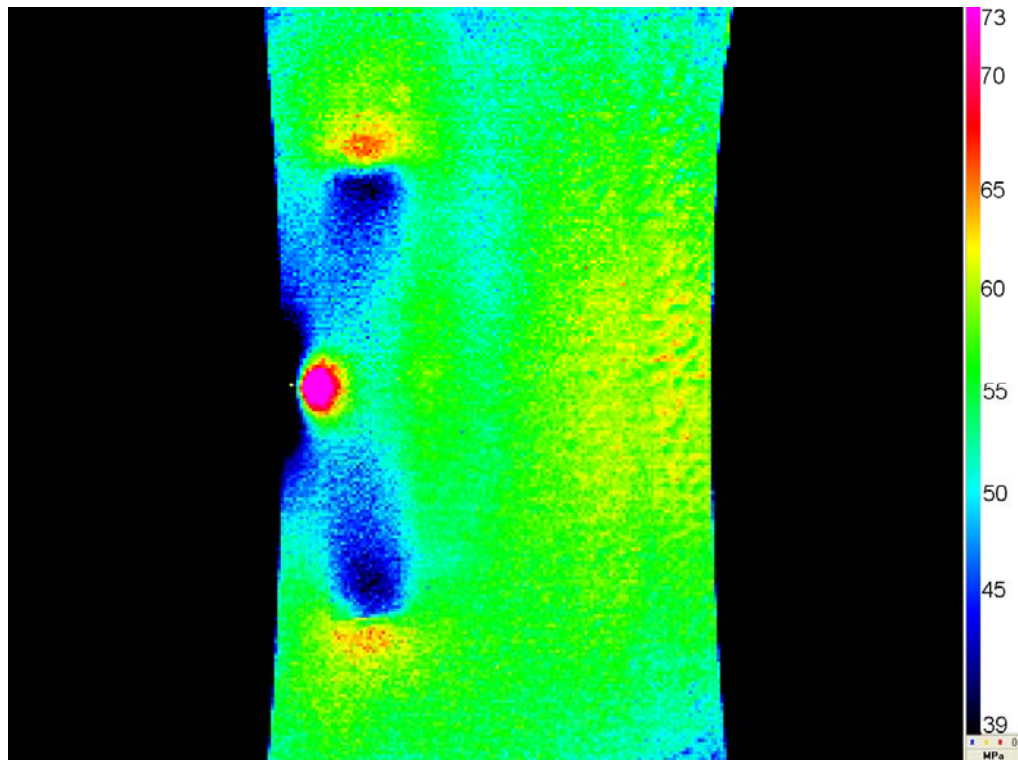
Figure 3: The stress field in the skin and the SPD strip

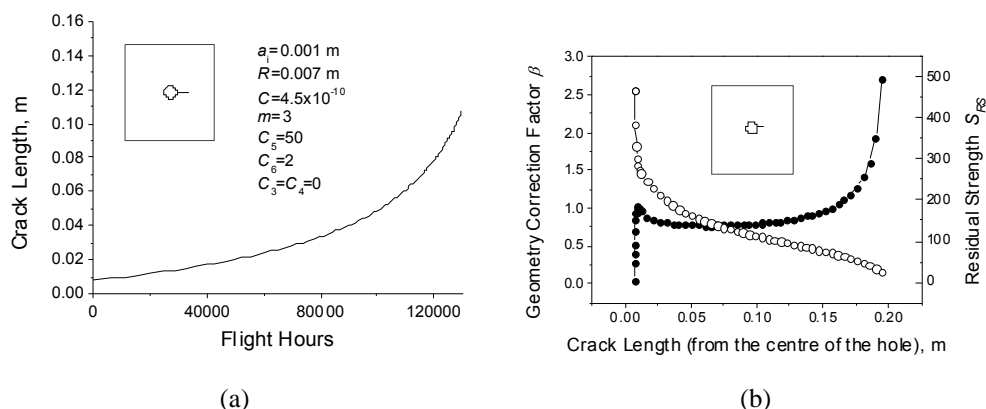
Figure 1: (a) The master crack growth curve, and (b) the geometry correction factor and the residual strengths for a plate with a central hole.

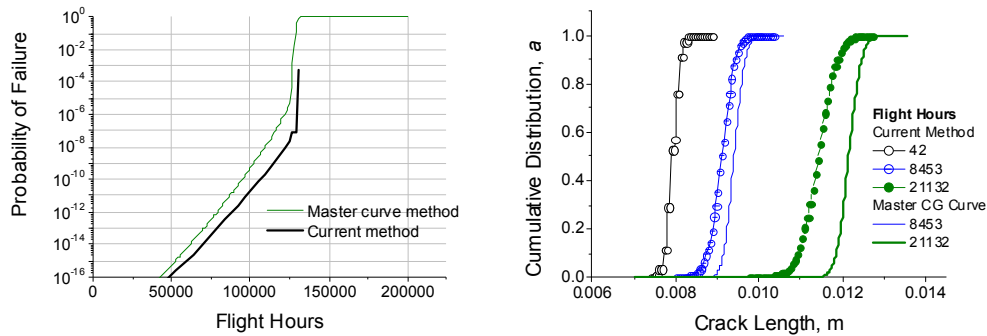
Figure 2: (a) The probability of failure curve (the 'current method' is the proposed integrated probabilistic method) and (b) the corresponding examples of distributions of crack length at different flight hours for a plate with a central hole.

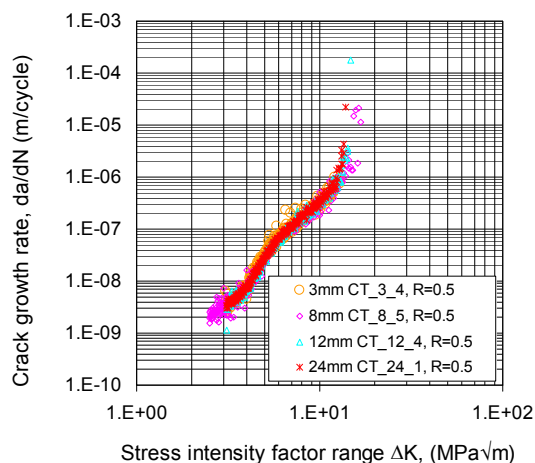
Figure 1: FCGR in AA7075-T7351 CT specimens with different thickness at R=0.5.

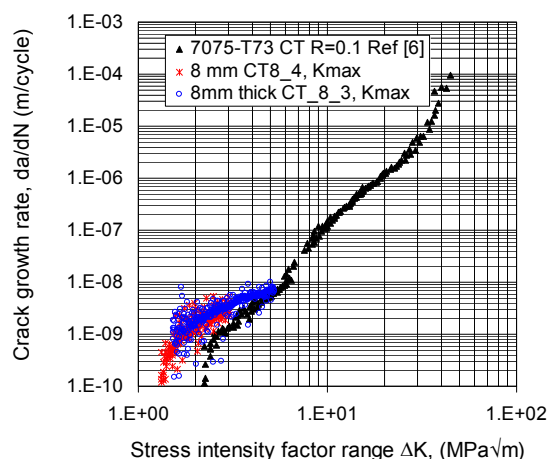
Figure 2: Threshold behaviour of AA7075-T7351 CT specimens for  $t=8.0$  mm.

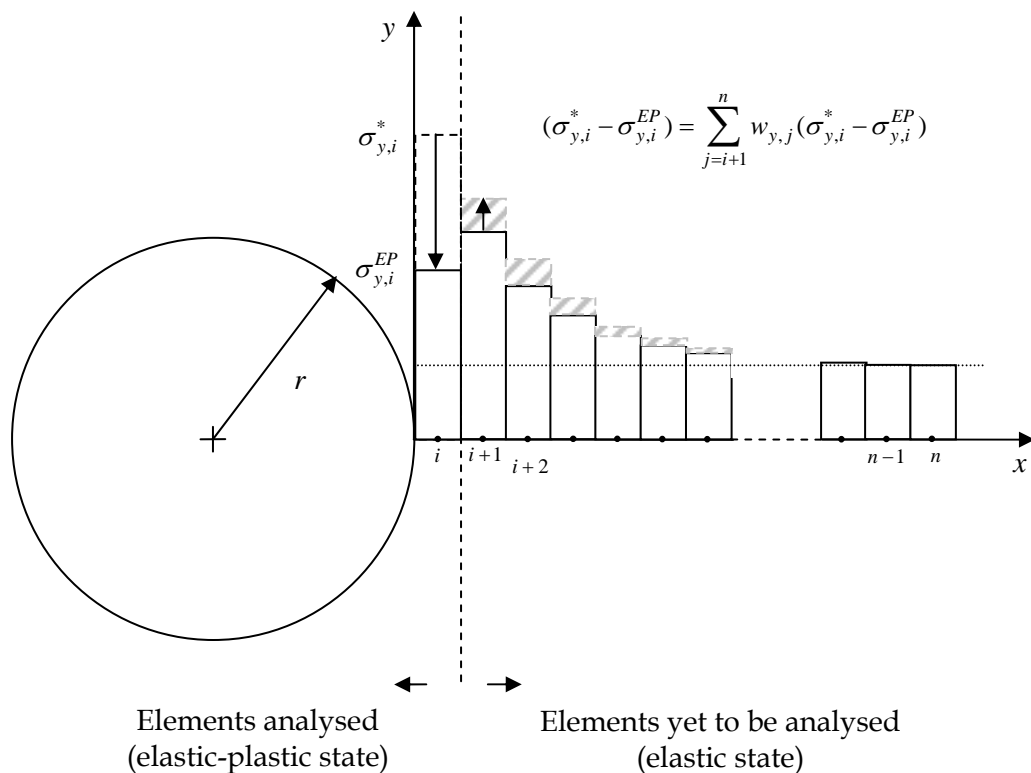
Figure 1: Redistributed stresses in the y-direction after the analysis of element  $i$ .

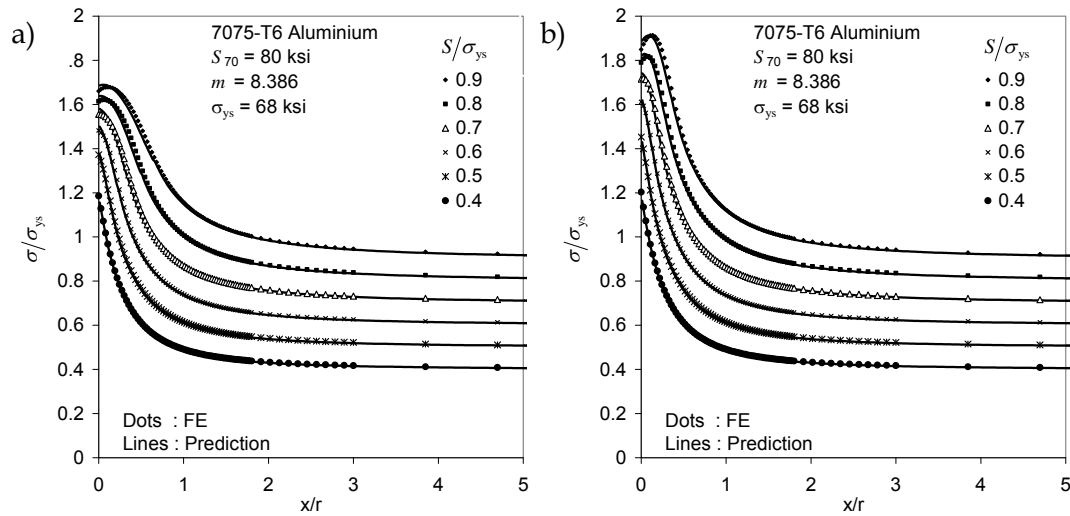
Figure 2: Comparison of the stress in the y-direction between the present methodology and FE analysis under a) plane stress and b) plane strain conditions for 7075-T6 Aluminium

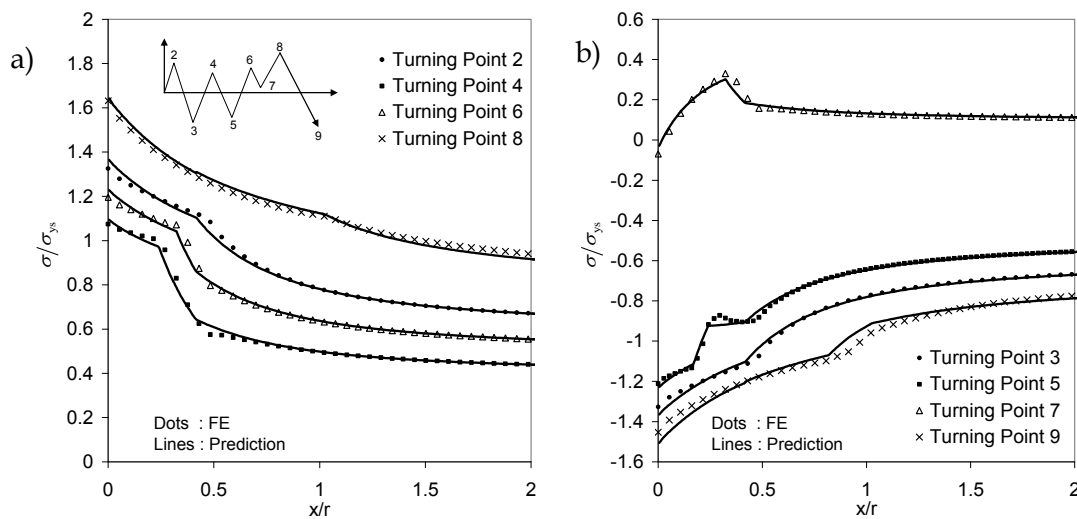
Figure 3: Comparison of the stress in the y-direction between the present methodology and FE analysis under plane stress conditions for 7050-T7451 Aluminium a) Peaks b) Valleys

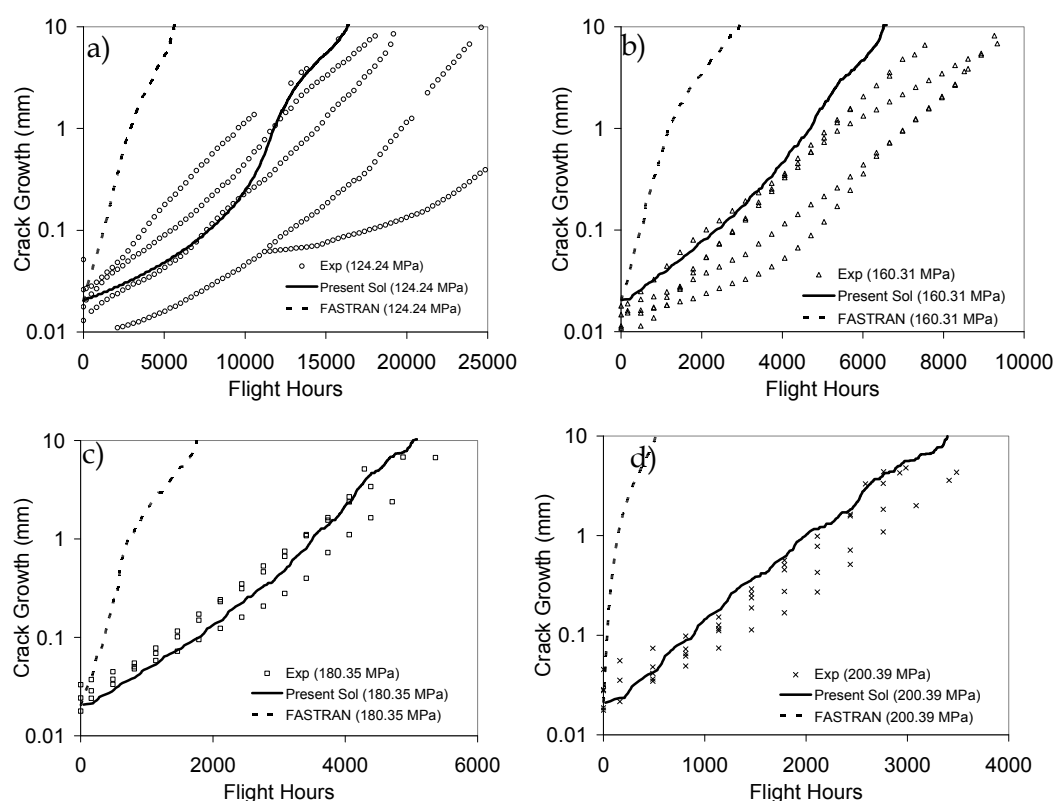
Figure 1: Crack growth curves for a single through- thickness crack emanating from the edge of a central hole in a plate subjected to an F/A-18 load sequence scaled by a) 124 MPa b) 160 MPa c) 180 MPa and d) 200 MPa.

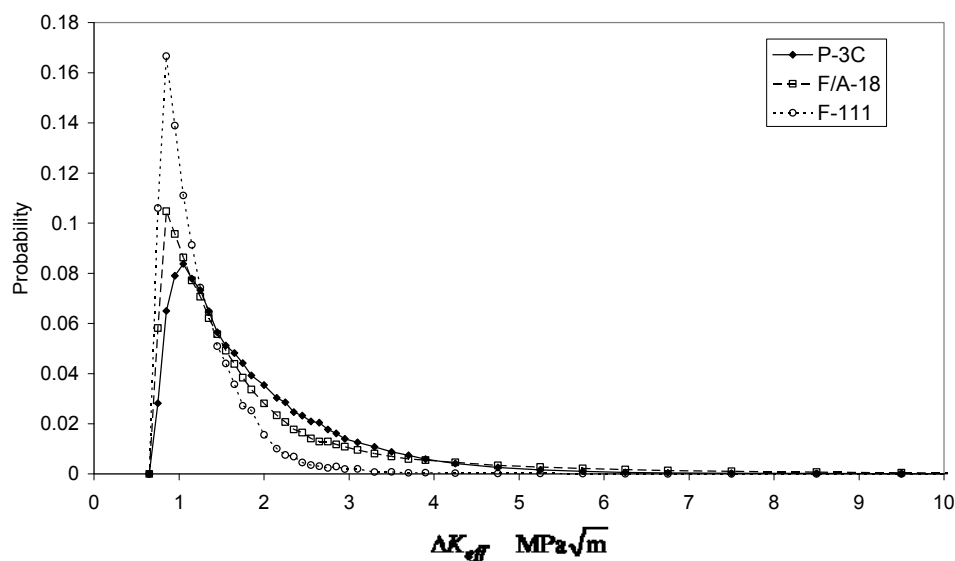
Figure 1: Probability density of  $\Delta K_{eff}$  for crack growth under the F-111, F/A-18 and P-3C spectrums

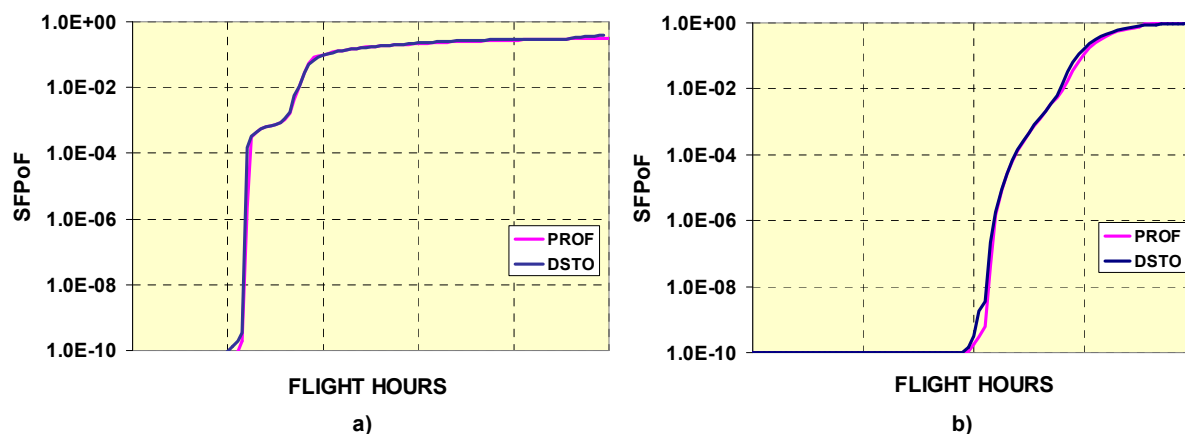
Figure 1: Comparison of PROF and DSTO in-house analysis programs a) SFPoF from PROF program sample problem; b) SFPoF for C130 CW-1

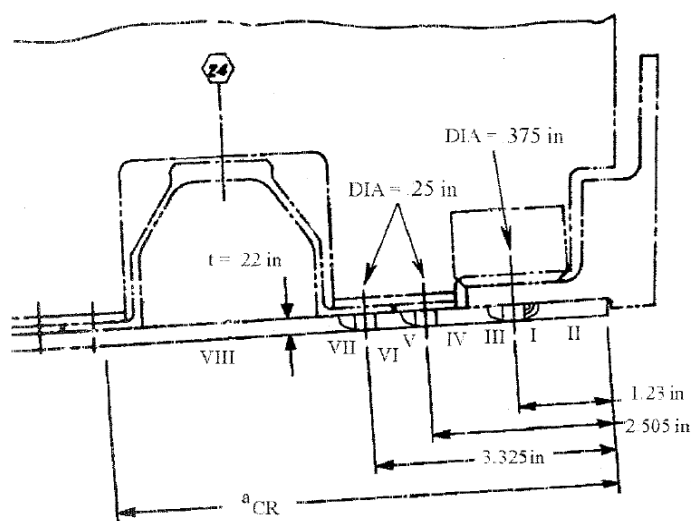
Figure 2: DTA analysis location showing crack growth phases

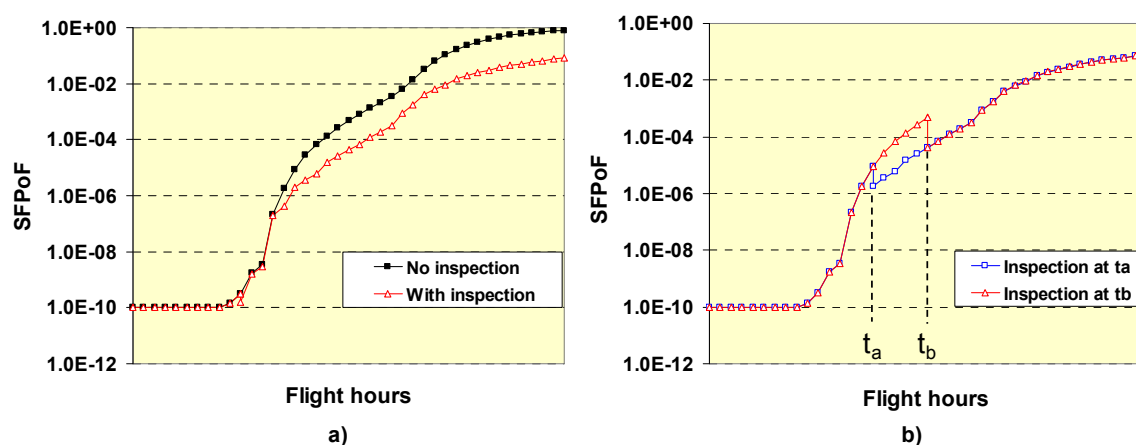
Figure 3: SFPoF curves comparison a) With and without inspection; b) Varying inspection times.

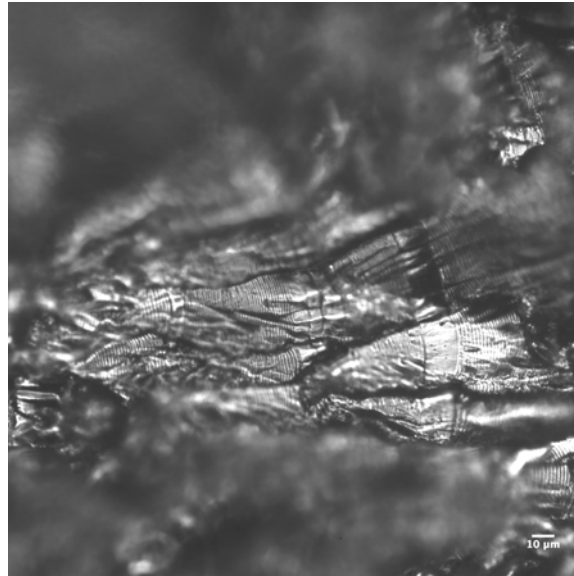
*Figure 1: Shows the small segments of a particular variable amplitude or constant amplitude loading sequence. Comparisons of the crack growth for each band are made to determine equivalent crack growth cycles*

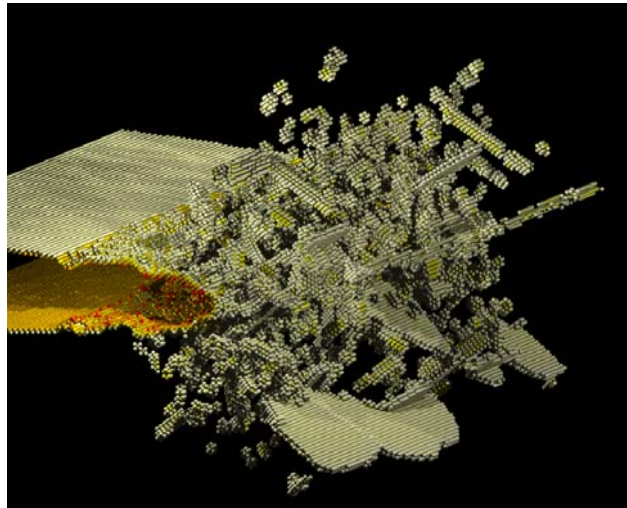
*Figure 2: Molecular dynamic simulation showing the atomic arrangement at the tip of a fatigue crack . This figure shows only atoms displaced from the original fcc lattice. 15 loading cycles were applied to develop the complex structure at the tip*

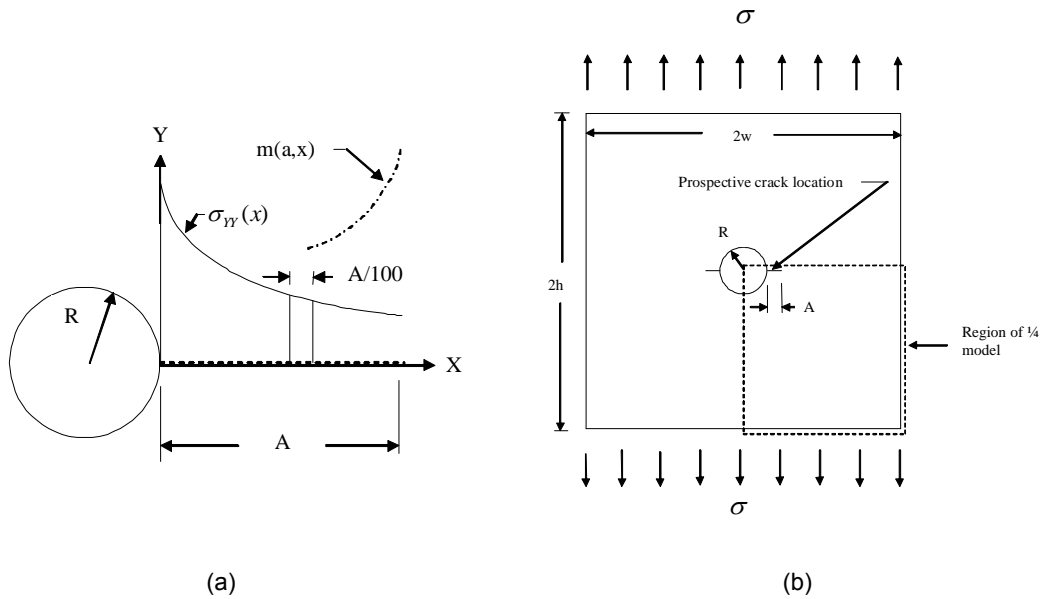
Figure 1: Notation and geometry for analysis of overloaded plate containing hole (a) local detail for calculation of stress intensity factor, (b) plate arrangement for FEA showing prospective crack location.

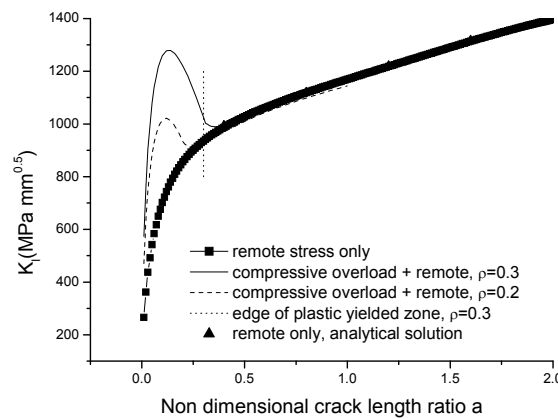
Figure 2: Stress intensity factor results due to remote compression overload for large D6AC plate, following overload, with subsequent remote stress of 200MPa.

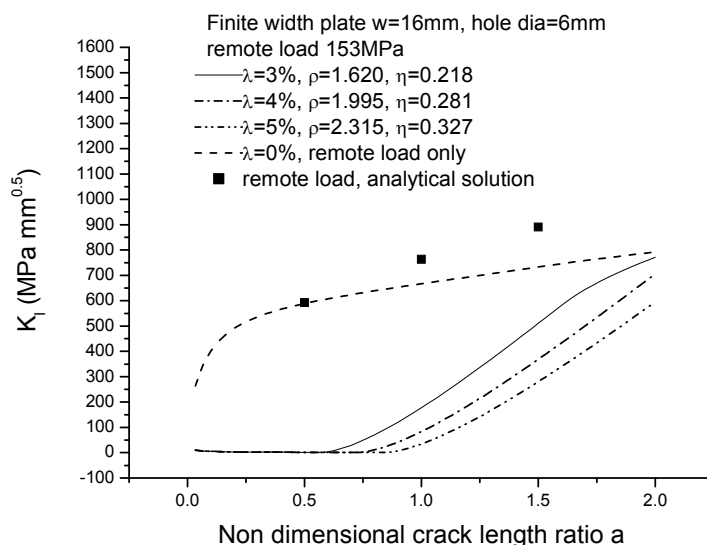
Figure 5: Stress intensity factor results for finite width Al. alloy C-130 test coupons with  $w/R=5.33$  due to cold expansion and with subsequent remote stress of 153MPa.

The application of cold expansion to an Aluminium alloy fatigue test coupon representing a lower wing skin location in the C-130 is considered. It is shown that a much larger initial plastic zone size is achieved, Figure 5, by cold expansion resulting in an increased benefit in comparison to the D6AC steel example.

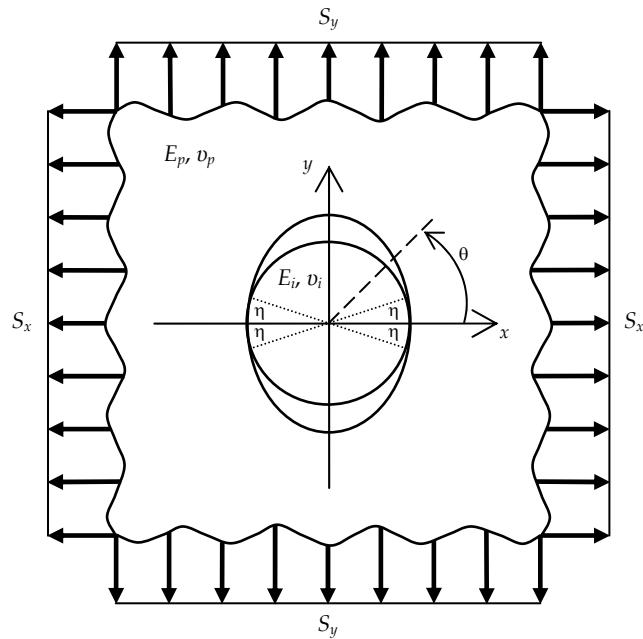
Figure 1: Geometrical configuration of an infinite 2D plate loaded by stresses  $S_x$  and  $S_y$  at infinity showing the contact angle  $\eta$  between the plate and the circular pin insert.

Finite element analysis work has been undertaken to study the effects of contact interaction between a neat-fit and a range of clearance-fit unloaded titanium alloy pins and a fastener hole in an aluminium alloy plate loaded in uniaxial tension (idealised as shown in Figure 1, with  $S_y > 0$  and  $S_x = 0$ , and contact angle  $\eta$ ). This work supports a fatigue coupon testing program that is being conducted for the validation of test interpretation activities associated with the BAE Systems Lead-In Fighter (LIF) Hawk full-scale fatigue test that is presently being undertaken by AVD. The aim is to gain a better understanding of the stress distributions that occur when fasteners are fitted in holes. Anecdotal evidence would seem to indicate that the crack initiation point at the hole boundary is offset by a small angle relative to the point of maximum stress when the hole is empty. Results have been obtained for linear-elastic pin-hole contact interactions, and these have been compared to the two-dimensional results obtained using a known analytical solution technique. Because it involves considerable numerical computations, this technique has been implemented in a Fortran 90 software program, and it permits the study of contact pressures and tangential stresses for pin-hole contact interactions where the elastic material properties of the pin and plate material are different, and where the applied loading can be biaxial or uniaxial in nature. Both 2D and 3D finite element analyses of the pin-hole contact problem have been conducted, for the case of an unloaded neat-fit titanium pin in a uniaxially-loaded aluminium plate. Excellent agreement has been obtained with the computed 2D analytical results (see Figure 2). Both the 2D and 3D linear elastic results indicate that the peak tangential stress around the hole occurs at an angle of approximately  $\theta = 20^\circ$  under uniaxial tension loading, rather than at  $\theta = 0^\circ$  as for an empty hole (see Figures 2 and 3). Further finite element analyses involving elasto-plastic material behaviour are now being conducted to study the effects of material plasticity and cyclic loading on the stress distribution associated with pin-hole contact problems.

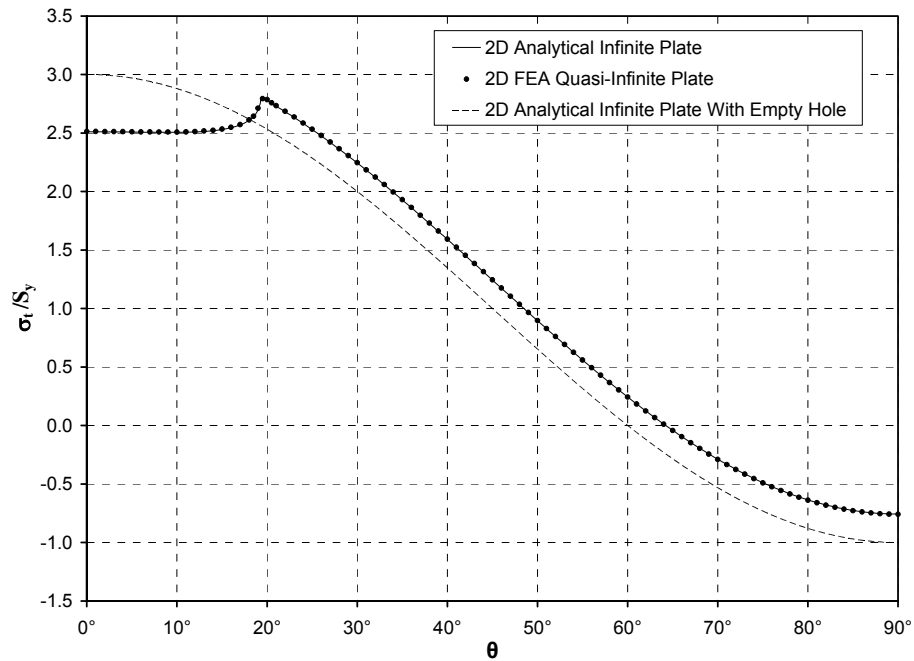
Figure 2: Variation of normalised tangential stress around a hole in a uniaxially-loaded square aluminium plate with a neat-fit titanium pin. Results obtained from 2D finite element analysis of a quasi-infinite plate and the corresponding analytical infinite-plate solution.

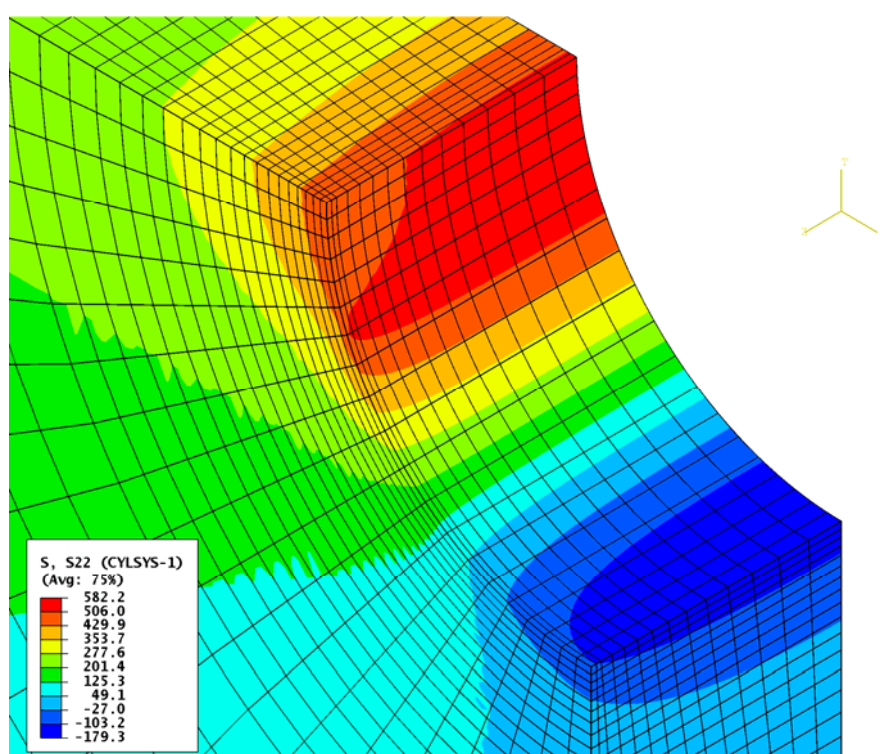
Figure 3: Contour plot of tangential stress in the vicinity of the hole for an aluminium plate loaded in uniaxial tension with a neat-fit titanium pin insert in the hole, as obtained from a 3D 1/8-symmetry linear-elastic finite element analysis.

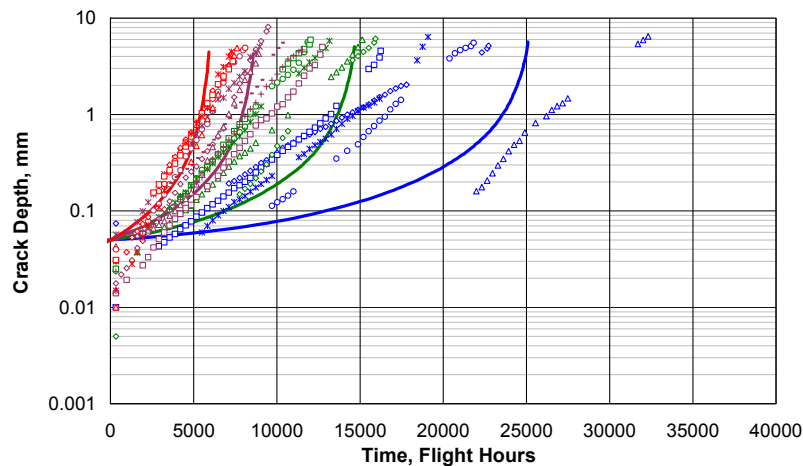
Figure 1: Example (from [1]) of poor analytical results compared with experiment. The experimental data are shown as symbols, and the analyses as solid curves. The four sets are for tests under the same load sequence at different stress scaling levels.

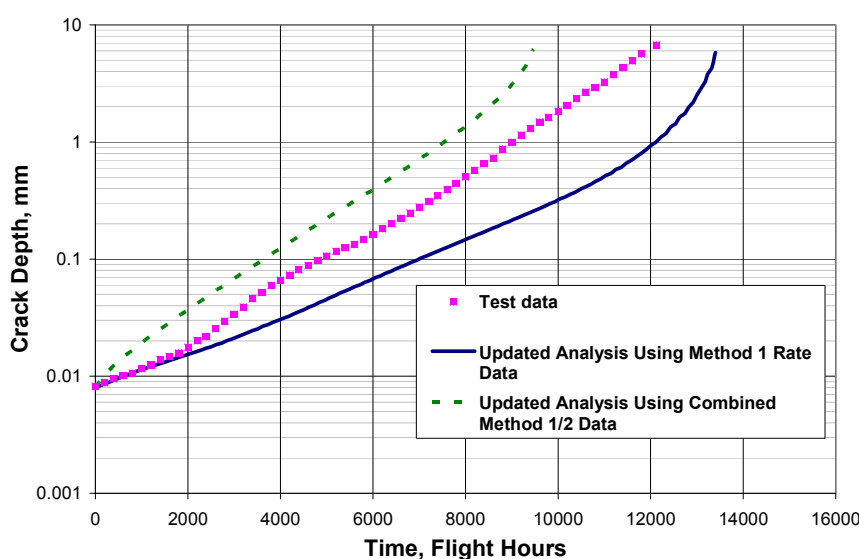
Figure 2: Comparison between test data and updated analysis showing greatly improved result

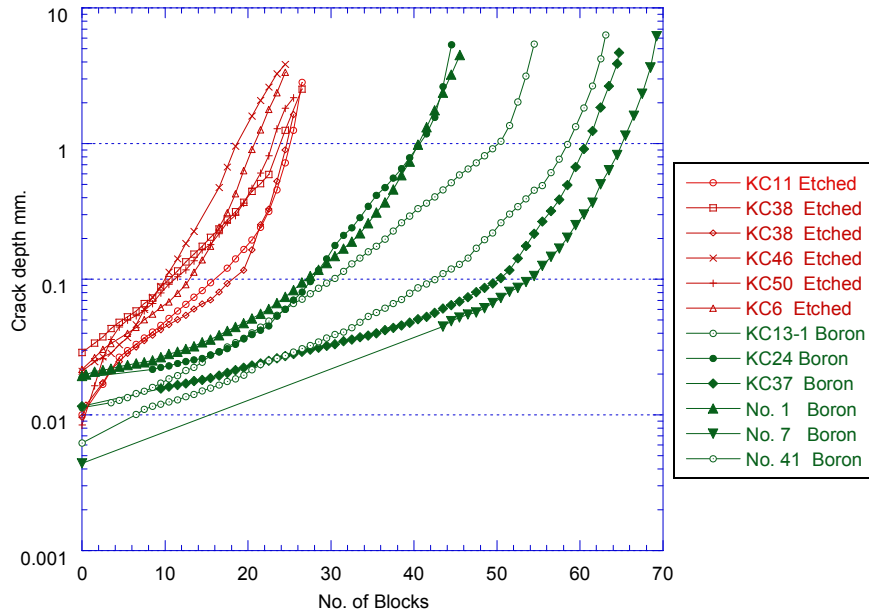
Figure 1: Crack growth curves for coupons tested with the same measured strains in the aluminium alloy. One set of graphs shows the results form coupons that were etched and the second for coupons that had boron doublers applied.

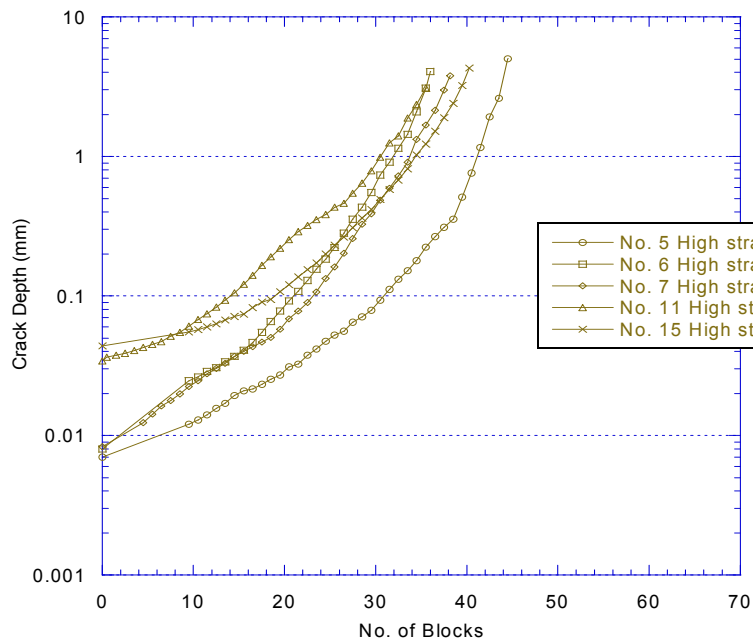
Figure 2: Crack growth curves for coupons tested with boron doublers applied loaded at strain levels about 15 % higher than those shown in Figure 1.

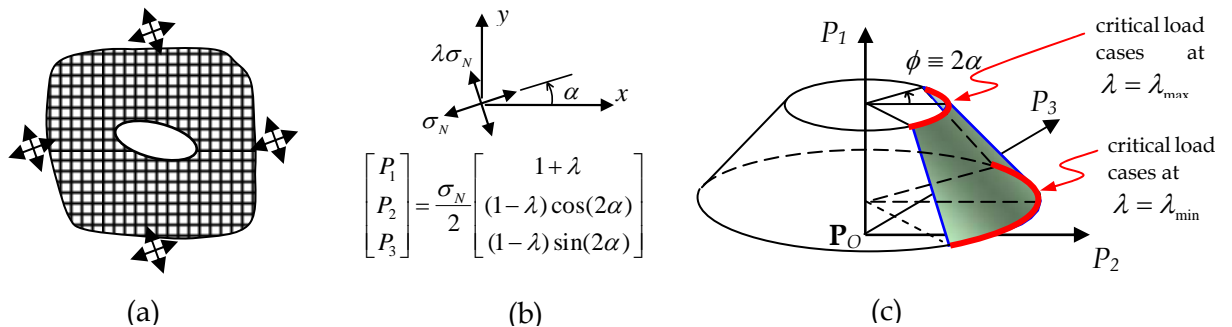
Figure 1: Constructing critical load cases for a centre-holed 2-D plate under remote biaxial stresses. (a) Illustration of the plate under remote stresses; (b) Continuous variations of stress ratio and orientation, represented by general load vector; (c) Critical load cases identified from collection of all load cases (the latter is shown as shaded area).

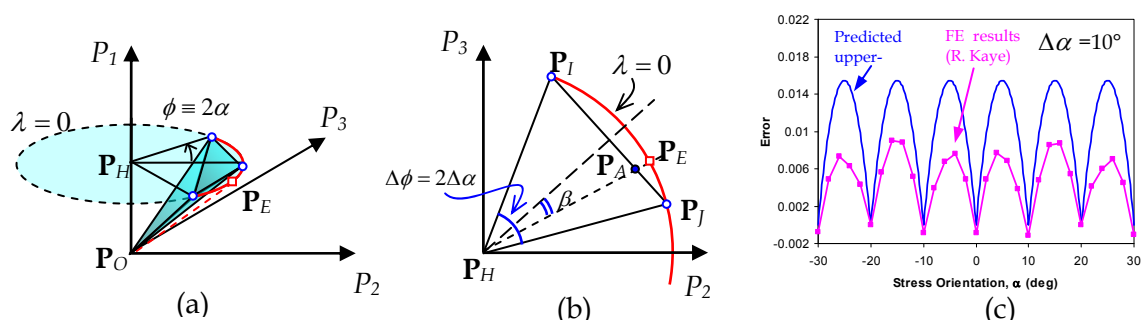
Figure 2: Errors induced by discretising continuous load cases. (a) Plot of load cases in a 3-D load space; (b) Load cases projected onto a 2-D sub-space; (c) Comparison with FE results showing upper-bound nature of the theoretical error estimation.

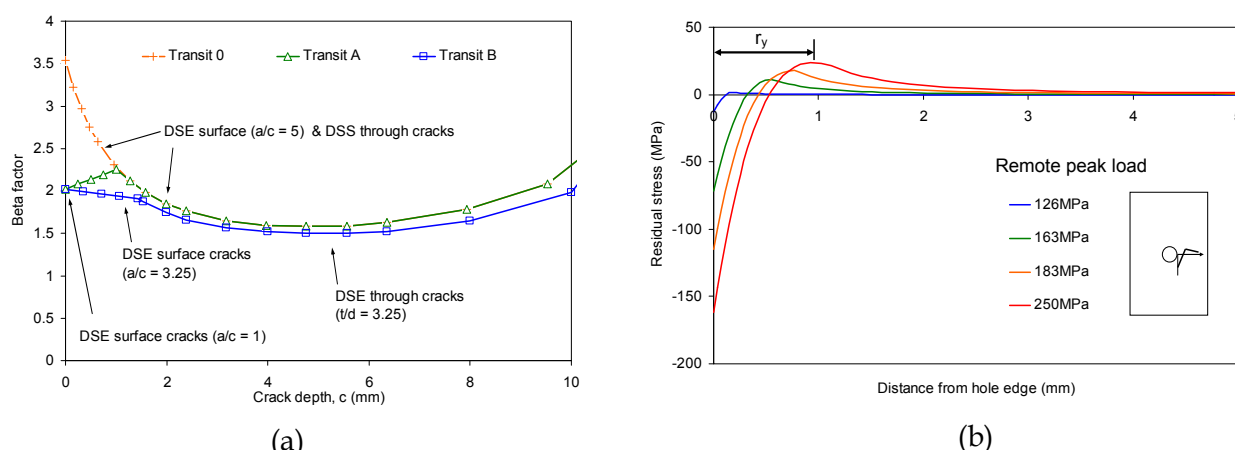
Figure 3: Plots showing sources that affect beta factor estimation. (a) Aspect ratio of DSE (double symmetry elliptical) surface crack in high  $K_t$  coupon (plate with a centre hole); (b) Residual stress induced by remote peak load in high  $K_t$  coupon.
